SOMETHING GREEN A DAM
WASHINGTON COUNTY, MISSOURI
MO 30720

SOMETHING GREEN B DAM
WASHINGTON COUNTY, MISSOURI
MO 30719

PHASE 1 INSPECTION REPORT NATIONAL DAM SAFETY INSPECTION

SEPTEMBER 1980

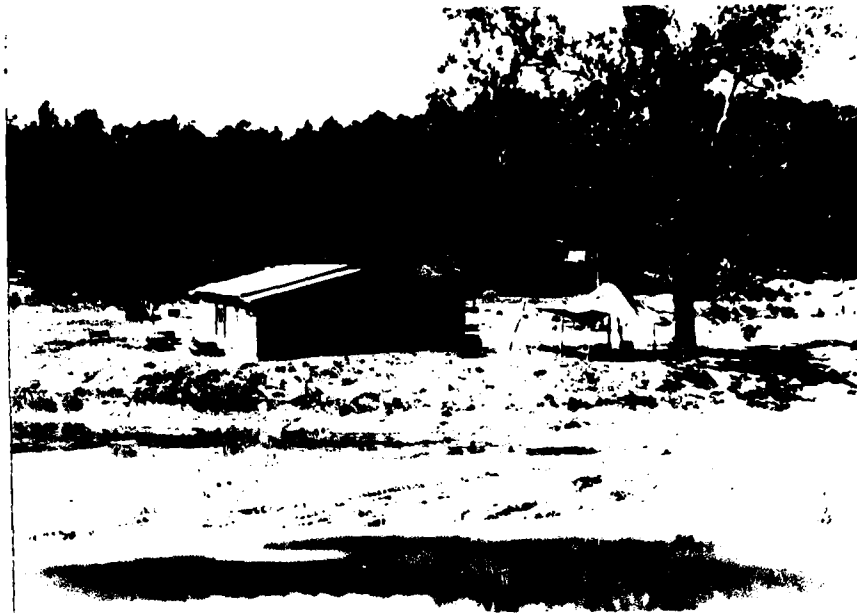
5. Community recreation center downstream of dam. Looking southeast across drainage.
